**Flood Control Project Maintenance
Levee Inspections****LMA District Cover Sheet****Spring 2014 Levee Inspection Results****Reclamation District No. 2101 Blewett**

Spring 2014 Levee Inspection Results

Reclamation District No. 2101 Blewett

Waterway			Bank	Unit Miles
Unit No. 01 San Joaquin River			Left	3.20
	Spring (March - May)	Summer (June - August)	(September - November) Fall	Winter (December - February)
Unit Maintenance Rating (Fall Only)				
Date of Inspection	05/20/2014 - 05/20/2014			
DWR Inspector	Maksim Khashchuk			
Accompanied By	Jim Coddington RD2101

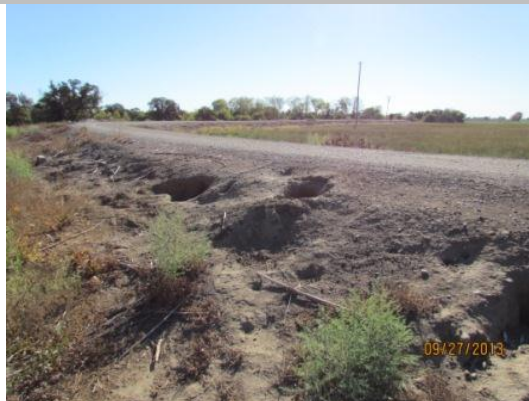
Photo 1 of 1 : mkhashch_s_20140428_00825.jpg

LM Start	0.04	Rating **	U	Issue No.	12
LM End	0.04	Issue Type +	Ma	Location *	WS
Category	Earthen Levee			GPS Latitude/Longitude	
				Start	End
Item	Animal Control			37.657648 °	37.657648 °
				-121.253812 °	-121.253812 °
DWR ID	DWR_RD2101_01_s _ 2012_12				
Action/Comments					
No rodents visible, but rodent burrows visible; need to backfill and compact or grout burrows.

View of rodent holes on waterward slope, facing upstream.

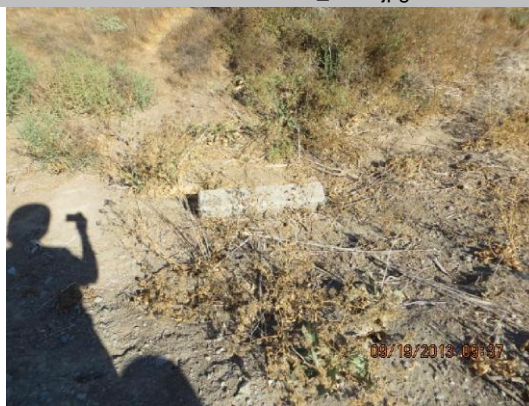
Photo 1 of 1 : UCIP_5282.jpg

LM Start	0.05	Rating **	M	Issue No.	60
LM End	0.05	Issue Type +	En	Location *	WS
Category	Supplemental			GPS Latitude/Longitude	
				Start	End
Item	DWR UCIP Field Study			37.657801 °	37.657801 °
				-121.253745 °	-121.253745 °
DWR ID	DWR_RD2101_01_s _ 2014_60				
Action/Comments					
Inspector Comments: FS_ID:26403					
EP_NO: N/A					
Repair Type:					
Crossing Status:					
UCIP Comments: Slide gate missing from WS toe. Pipe has heavy sediment buildup.					
FIELD_STRUCT_DESC: 18-inch corrugated metal pipe through levee 3-feet below crown. Concrete headwall on both ends. Slide gate at headwall on the waterward end. Originally included in the 1968 O&M manual.					
FS Date: 9/17/2013

Headwall on WS toe.

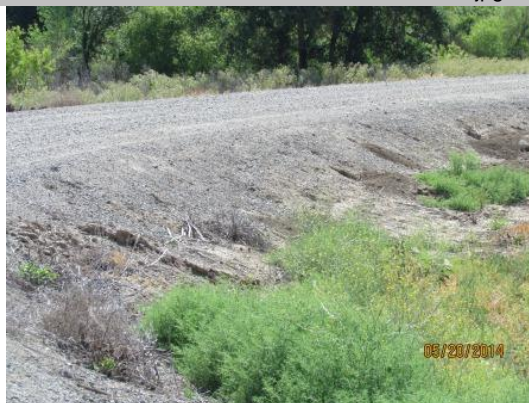
Photo 1 of 1 : mkhashch_s_20140527_01043.jpg

LM Start	0.07	Rating **	M	Issue No.	16
LM End	0.07	Issue Type +	Ma	Location *	LS
Category	Earthen Levee			GPS Latitude/Longitude	
				Start	End
Item	Animal Control			37.657811 °	37.657811 °
				-121.253269 °	-121.253269 °
DWR ID	DWR_RD2101_01_s _ 2013_16				
Action/Comments					
No rodents visible, but rodent burrows visible; need to backfill and compact or grout burrows.

View of rodent burrows on the landside levee slope.

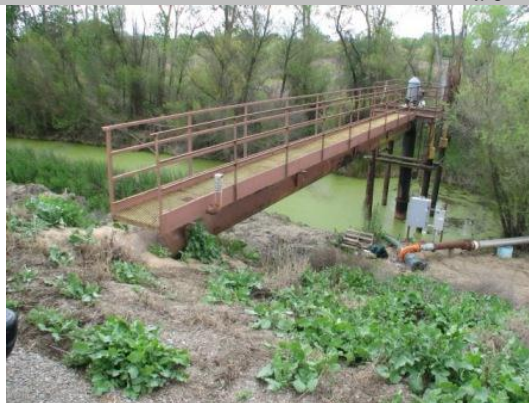
Photo 1 of 1 : mkhashch_s_20140428_00823.jpg

LM Start	0.19	Rating **	A/W	Issue No.	7
LM End	0.19	Issue Type +	En	Location *	CR
Category	Earthen Levee			GPS Latitude/Longitude	
				Start	End
Item	Encroachments			37.657128 °	37.657128 °
				-121.251692 °	-121.251692 °
DWR ID	DWR_RD2101_01_s _ 2012_7				
Action/Comments					
Pipe

Drainage discharge under levee crown.

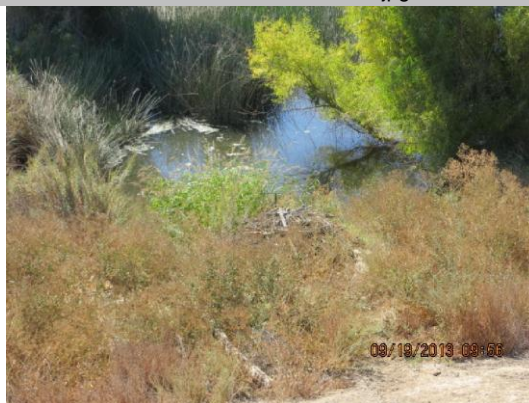
Photo 1 of 1 : UCIP_2344.jpg

LM Start	0.32	Rating **	M	Issue No.	61
LM End	0.32	Issue Type +	En	Location *	CR
Category	Supplemental			GPS Latitude/Longitude	
				Start	End
Item	DWR UCIP Field Study			37.658142 °	37.658142 °
				-121.250046 °	-121.250046 °
DWR ID	DWR_RD2101_01_s _ 2014_61				
Action/Comments					
Inspector Comments: FS_ID:20785					
EP_NO: N/A					
Repair Type:					
Crossing Status:					
UCIP Comments: Inlet blocked by soil from beaver activity. Outlet covered in soil.					
FIELD_STRUCT_DESC: 24-inch corrugated metal pipe through levee 21.0 feet below crown. Headwall and slide gate on the landward end. Concrete "U" headwall and flap gate on the waterward end. Originally included in the 1968 O&M manual.					
FS Date: 9/19/2013

Slide gate at concrete headwall on LS toe.

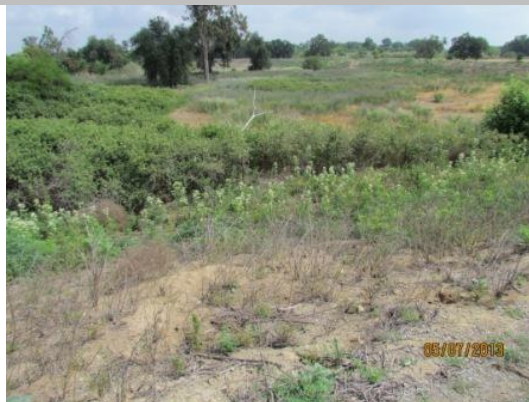
Photo 1 of 1 : mkhashch_s_20140428_00843.jpg

LM Start	0.70	Rating **	U	Issue No.	26
LM End	0.70	Issue Type +	Ma	Location *	WS
Category	Earthen Levee			GPS Latitude/Longitude	
				Start	End
Item	Animal Control			37.659907 °	37.659907 °
				-121.244219 °	-121.244219 °
DWR ID	DWR_RD2101_01_s _ 2013_26				
Action/Comments					
Exterminate rodents and backfill and compact or grout burrows.

View of the rodent burrows on the waterside levee slope.

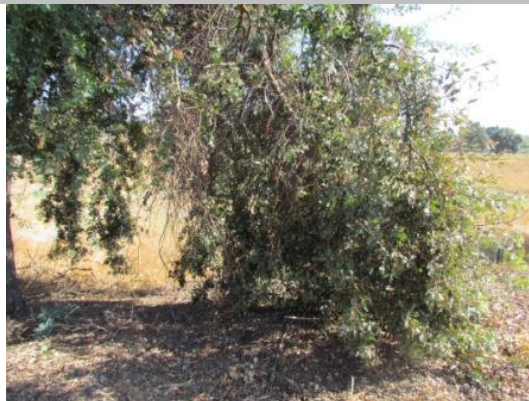
Photo 1 of 1 : mkhashch_s_20140428_00824.jpg

LM Start	0.75	Rating **	M	Issue No.	11
LM End	0.75	Issue Type +	Ma	Location *	WS
Category	Earthen Levee			GPS Latitude/Longitude	
				Start	End
Item	Trim / Thin Trees			37.659705 °	37.659705 °
				-121.243306 °	-121.243306 °
DWR ID	DWR_RD2101_01_f_2012_11				
Action/Comments					
Trim trees to at least five feet above ground level. Inspector Comments: Trim tree to allow access and visibility.

View of tree branches obstructing waterside slope.

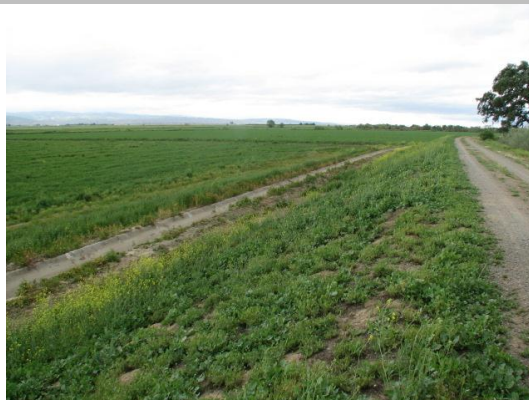
Photo 1 of 1 : mkhashch_s_20140428_00852.jpg

LM Start	0.76	Rating **	M	Issue No.	944
LM End	1.80	Issue Type +	En	Location *	LS
Category	Earthen Levee			GPS Latitude/Longitude	
				Start	End
Item	Encroachments			37.659827 °	37.651049 °
				-121.243675 °	-121.231475 °
DWR ID	DWR_RD2101_01_s_2012_944				
Action/Comments					
Ditch

Concrete ditch near landside toe.

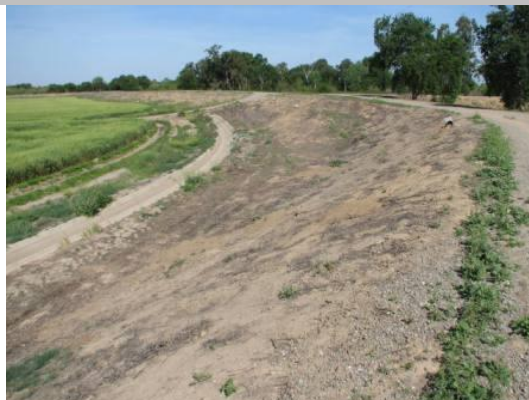
Photo 1 of 1 : mkhashch_s_20140428_00839.jpg

LM Start	0.80	Rating **	M	Issue No.	22
LM End	0.80	Issue Type +	Ma	Location *	LS
Category	Earthen Levee			GPS Latitude/Longitude	
				Start	End
Item	Animal Control			37.659302 °	37.659302 °
				-121.242875 °	-121.242875 °
DWR ID	DWR_RD2101_01_s_2012_22				
Action/Comments					
Exterminate rodents and backfill and compact or grout burrows.

View of levee material removed by rodent activity on landside slope facing downstream. 05/02/2012

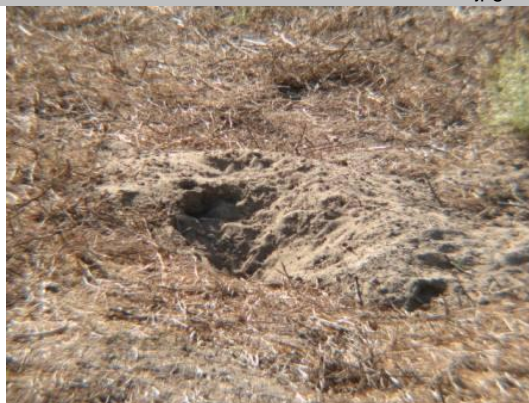
Photo 1 of 1 : mkhashch_s_20140428_00822.jpg

LM Start	0.88	Rating **	M	Issue No.	3
LM End	0.88	Issue Type +	Ma	Location *	LS
Category	Earthen Levee			GPS Latitude/Longitude	
				Start	End
Item	Animal Control			37.658663 °	37.658663 °
				-121.241750 °	-121.241750 °
DWR ID	DWR_RD2101_01_s _ 2012_3				
Action/Comments					
No rodents visible, but rodent burrows visible; need to backfill and compact or grout burrows.

11/02/2011 Active rodent burrow.

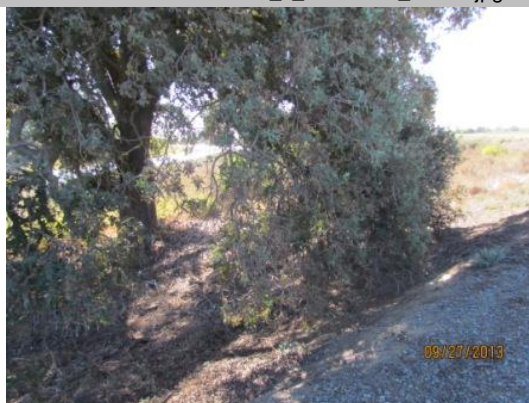
Photo 1 of 1 : mkhashch_s_20140428_00840.jpg

LM Start	1.09	Rating **	M	Issue No.	23
LM End	1.09	Issue Type +	Ma	Location *	WS
Category	Earthen Levee			GPS Latitude/Longitude	
				Start	End
Item	Trim / Thin Trees			37.655688 °	37.655688 °
				-121.241202 °	-121.241202 °
DWR ID	DWR_RD2101_01_s _ 2012_23				
Action/Comments					
Trim trees to at least five feet above ground level.

View of a tree limb touching the waterside levee slope. Must be trimmed at least 5 feet away from the levee slope.

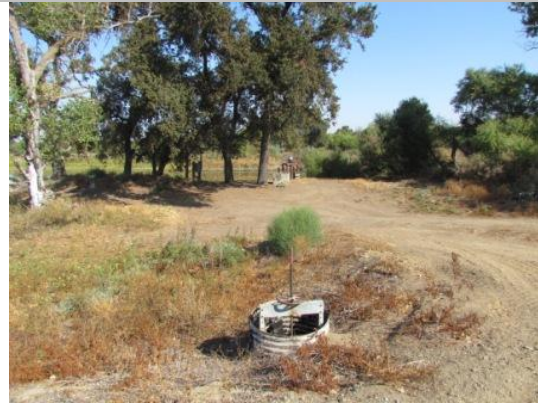
Photo 1 of 1 : mkhashch_s_20140428_00826.jpg

LM Start	1.62	Rating **	A/W	Issue No.	13
LM End	1.62	Issue Type +	Ma	Location *	WS
Category	Earthen Levee			GPS Latitude/Longitude	
				Start	End
Item	Encroachments			37.651555 °	37.651555 °
				-121.234319 °	-121.234319 °
DWR ID	DWR_RD2101_01_s _ 2012_13				
Action/Comments					
Pipe Inspector Comments: Pipe penetrates through levee. Closure valve on water side slope.

Photo of pump in background and CMP riser with valve in foreground.

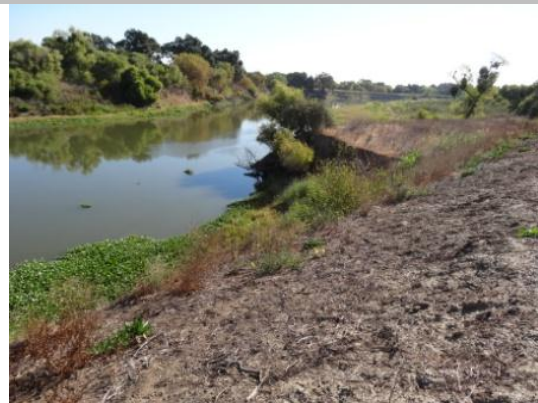
Photo 1 of 1 : mkhashch_s_20140428_00821.jpg

LM Start	1.91	Rating **	U	Issue No.	1
LM End	2.00	Issue Type +	Ma	Location *	WS
Category	Supplemental			GPS Latitude/Longitude	
				Start	End
Item	DWR Erosion Survey			37.650259 °	37.650259 °
				-121.228961 °	-121.228961 °
DWR ID	DWR_RD2101_01_s _ 2014_1				
Action/Comments					
Inspector Comments: 09/20/2013: Site has been visited. There are signs of further erosion development along the levee slope and toe. 07/18/2012: Erosion has further developed toward levee crown. Vegetation has been removed. 08/18/2011: Erosion progressed significantly during the past flood season. The levee toe along the erosion site was washed away, and the erosion has cut the levee structure up to the point about 1/3 of the levee slope. The scarp height is approximately 17 feet. Very dense vegetation and trees are visible. 10/19/2010: No significant changes observed on site. Remaining levee berm topsoil is of silty sand mixture. Erosion is near the downstream transition. An eddy has formed, and has scoured away a 100-foot section of the bank, possibly encroaching into the levee prism. Vegetation on site includes willows, oak, and cotton wood located from the bench to the toe. On the landside are rows of corn crop. 08/05/2010: Recommended for Repair, per CLRO. 2009: Site recommended as annual assessment and monitoring if critical erosion site, per CLRO CES Evaluation 2008 Report; an eddy has formed, eroding bank and intruding into the levee prism; Site # is the same as RM76.3, LM1.89; previously rated "U". 08/30/2007: Recommended for short list of immediate repair sites; silty sand levee material. [2013 Site ID:RD2101U01RM73.92]

Looking downstream of erosion.

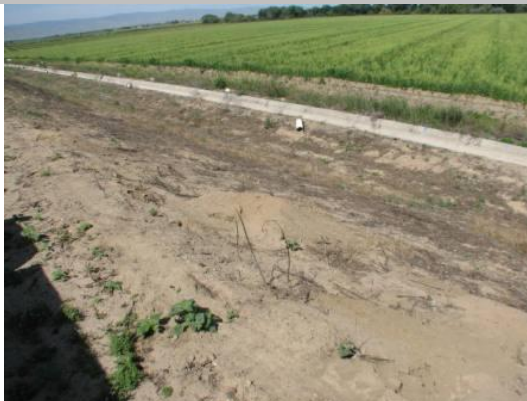
Photo 1 of 1 : mkhashch_s_20140428_00851.jpg

LM Start	2.39	Rating **	M	Issue No.	30
LM End	2.39	Issue Type +	Ma	Location *	LS
Category	Earthen Levee			GPS Latitude/Longitude	
				Start	End
Item	Animal Control			37.645785 °	37.645785 °
				-121.226337 °	-121.226337 °
DWR ID	DWR_RD2101_01_s _ 2012_30				
Action/Comments					
Exterminate rodents and backfill and compact or grout burrows.

View of levee material removed by rodent activity on landside slope, facing upstream. 05/02/2012

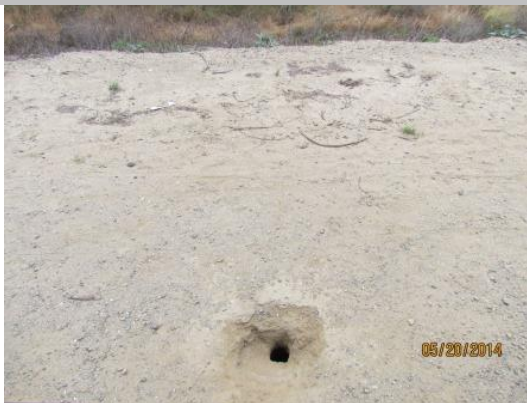
Photo 1 of 1 : mkhashch_s_20140527_01044.jpg

LM Start	2.68	Rating **	M	Issue No.	15
LM End	2.68	Issue Type +	Ma	Location *	CR
Category	Earthen Levee			GPS Latitude/Longitude	
				Start	End
Item	Animal Control			37.642815 °	37.642815 °
				-121.229935 °	-121.229935 °
DWR ID	DWR_RD2101_01_s _ 2014_15				
Action/Comments					
No rodents visible, but rodent burrows visible; need to backfill and compact or grout burrows.

View of the rodent hole on the levee crown.

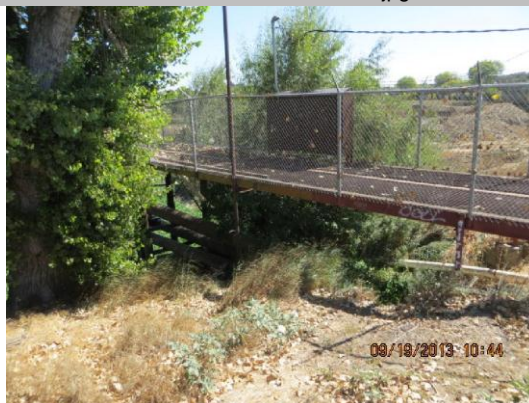
Photo 1 of 1 : UCIP_2348.jpg

LM Start	2.74	Rating **	M	Issue No.	62
LM End	2.74	Issue Type +	En	Location *	CR
Category	Supplemental			GPS Latitude/Longitude	
				Start	End
Item	DWR UCIP Field Study			37.641975 °	37.641975 °
				-121.229745 °	-121.229745 °
DWR ID	DWR_RD2101_01_s _ 2014_62				
Action/Comments					
Inspector Comments: FS_ID:20865					
EP_NO: N/A					
Repair Type:					
Crossing Status:					
UCIP Comments: Pipe leaking at pipe/concrete connection on WS slope.					
FIELD_STRUCT_DESC: 2 of 3: 20-inch steel pipe through levee 10.0-feet below crown encased in concrete. Pump on steel pier on WS. Gate valve in 16'X7' concrete vault on WS shoulder. Pipes discharge into concrete canal on LS toe. Originally included in the 1968 O&M manual.					
FS Date: 9/19/2013

Pump on metal pier on WS.

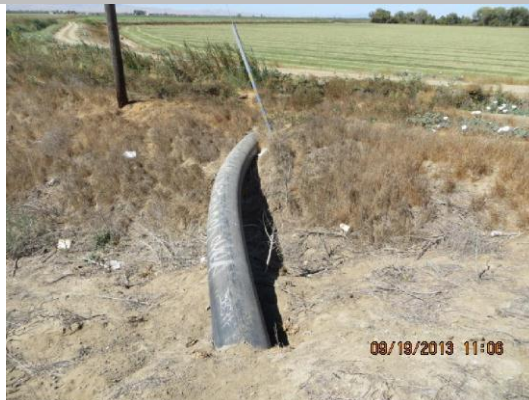
Photo 1 of 1 : UCIP_3265.jpg

LM Start	2.76	Rating **	M	Issue No.	63
LM End	2.76	Issue Type +	En	Location *	CR
Category	Supplemental			GPS Latitude/Longitude	
				Start	End
Item	DWR UCIP Field Study			37.641798 °	37.641798 °
				-121.229714 °	-121.229714 °
DWR ID	DWR_RD2101_01_s _ 2014_63				
Action/Comments					
Inspector Comments: FS_ID:22915					
EP_NO: N/A					
Repair Type:					
Crossing Status:					
UCIP Comments: No permit identified for this crossing.					
FIELD_STRUCT_DESC: 18-inch PVC irrigation pipe through the levee					
3.5-feet below the crown. No pump or other appurtances visible.					
FS Date: 9/19/2013

18-inch PVC pipe visible at LS slope.

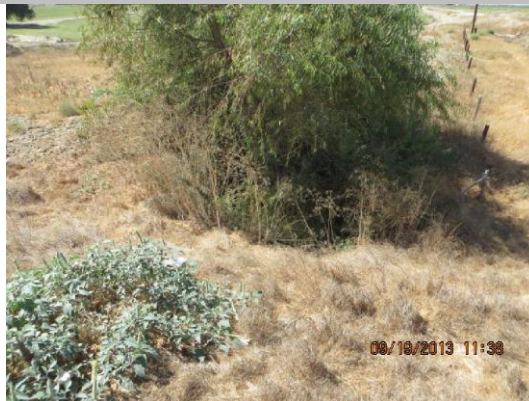
Photo 1 of 1 : UCIP_2356.jpg

LM Start	2.86	Rating **	M	Issue No.	64
LM End	2.86	Issue Type +	En	Location *	CR
Category	Supplemental			GPS Latitude/Longitude	
				Start	End
Item	DWR UCIP Field Study			37.640566 °	37.640566 °
				-121.230216 °	-121.230216 °
DWR ID	DWR_RD2101_01_s _ 2014_64				
Action/Comments					
Inspector Comments: FS_ID:20872					
EP_NO: N/A					
Repair Type:					
Crossing Status:					
UCIP Comments: Flap gate missing from WS headwall.					
FIELD_STRUCT_DESC: 24-inch corrugated metal drain pipe through					
levee 11.0 feet below crown. Concrete "U" headwall on both ends.					
Flap gate on waterward end. Originally included in the 1968 O&M					
manual.					
FS Date: 9/19/2013

Concrete headwall visible at LS toe in ditch.

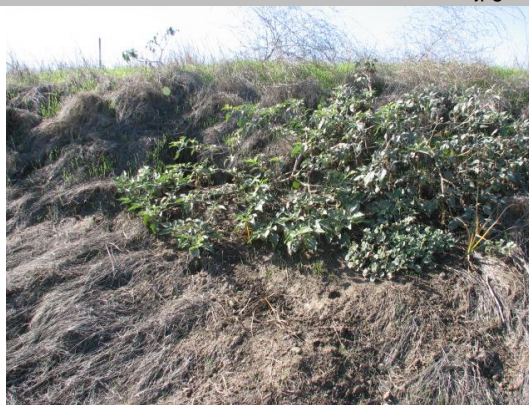
Photo 1 of 1 : mkhashch_s_20140428_00844.jpg

LM Start	2.88	Rating **	U	Issue No.	27
LM End	2.88	Issue Type +	Ma	Location *	WS
Category	Earthen Levee			GPS Latitude/Longitude	
				Start	End
Item	Animal Control			37.640305 °	37.640305 °
				-121.230095 °	-121.230095 °
DWR ID	DWR_RD2101_01_s _ 2012_27				
Action/Comments					
No rodents visible, but rodent burrows visible; need to backfill and compact or grout burrows. Inspector Comments: Active burrows with squirrels observed. Burrows on both sides of levee.

Rodent holes on levee slope hidden by vegetation.

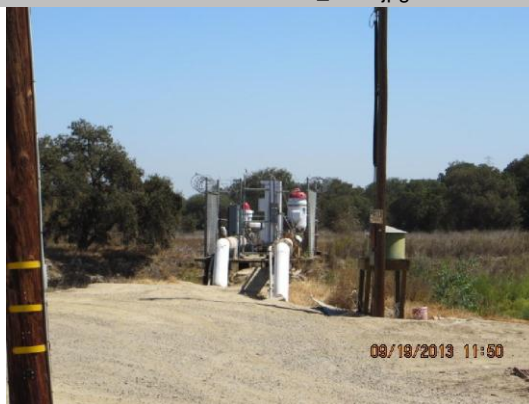
Photo 1 of 1 : UCIP_2362.jpg

LM Start	2.89	Rating **	M	Issue No.	66
LM End	2.89	Issue Type +	En	Location *	WS
Category	Supplemental			GPS Latitude/Longitude	
				Start	End
Item	DWR UCIP Field Study			37.640185 °	37.640185 °
				-121.230067 °	-121.230067 °
DWR ID	DWR_RD2101_01_s _ 2014_66				
Action/Comments					
Inspector Comments: FS_ID:20873					
EP_NO: N/A					
Repair Type:					
Crossing Status:					
UCIP Comments: Leaks off LS toe may indicate internal failure. Good candidate for video inspection.					
FIELD_STRUCT_DESC: 1 of 2: 24-inch concrete irrigation pipe through levee 11.0 feet below crown. Pump on metal pier at WS berm. Screw gates in 6'X10.5' concrete box on waterward side. 12-inch steel riser next to concrete box with slide gates. Abandoned pump house on waterward side. Originally included in the 1968 O&M manual.					
FS Date: 9/19/2013

Pumps on metal pier at WS berm.

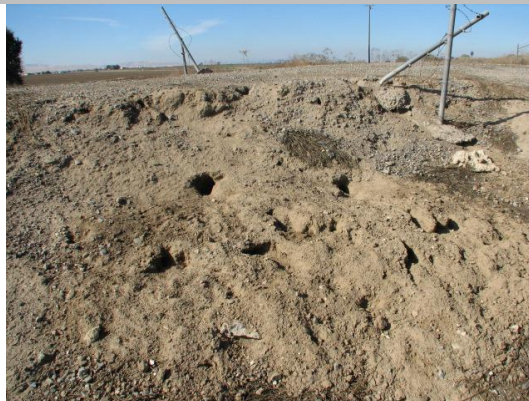
Photo 1 of 4 : mkhashch_s_20140428_00845.jpg

LM Start	2.89	Rating **	U	Issue No.	28
LM End	2.89	Issue Type +	Ma	Location *	LS
Category	Earthen Levee			GPS Latitude/Longitude	
				Start	End
Item	Animal Control			37.640134 °	37.640134 °
				-121.230019 °	-121.230019 °
DWR ID	DWR_RD2101_01_s _ 2012_28				
Action/Comments					
No rodents visible, but rodent burrows visible; need to backfill and compact or grout burrows. Inspector Comments: Numerous rodent holes throughout levee slope.

Rodent holes on levee slope.

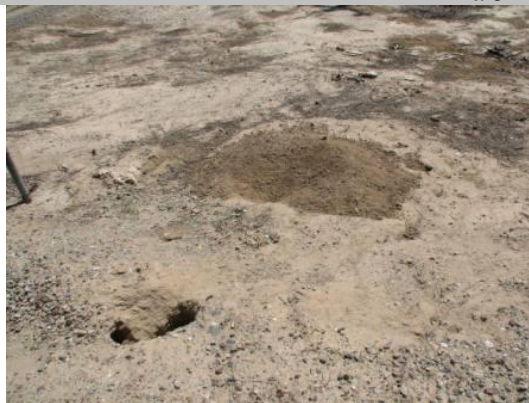
Photo 2 of 4 : mkhashch_s_20140428_00846.jpg

05/26/2011 Updated photo of animal control issue noted in Fall 2010 inspection, fresh rodent burrow present.

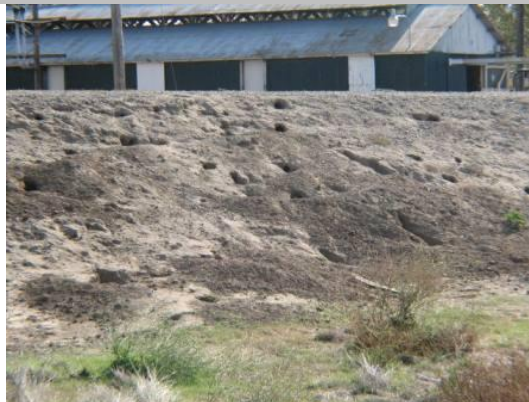
Photo 3 of 4 : mkhashch_s_20140428_00847.jpg

11/02/2011 Numerous burrows on levee slope.

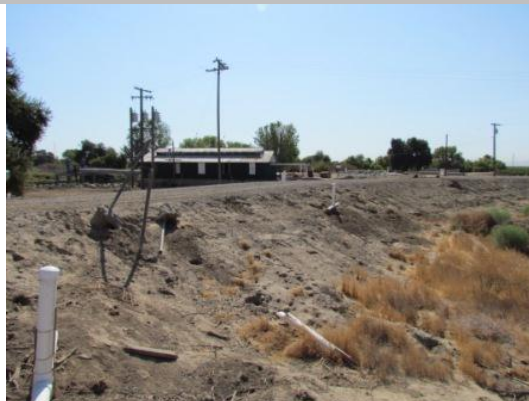
Photo 4 of 4 : mkhashch_s_20140428_00848.jpg

LM Start	2.89	Rating **	U	Issue No.	28 (cont)	
LM End	2.89	Issue Type +	Ma	Location *	LS	
Category	Earthen Levee			GPS Latitude/Longitude		
				Start	End	
Item	Animal Control			37.640134 °	37.640134 °	
				-121.230019 °	-121.230019 °	
DWR ID	DWR_RD2101_01_s _ 2012_28					
Action/Comments						
No rodents visible, but rodent burrows visible; need to backfill and

View of numerous rodent holes with bait stations present. 09/25/2012

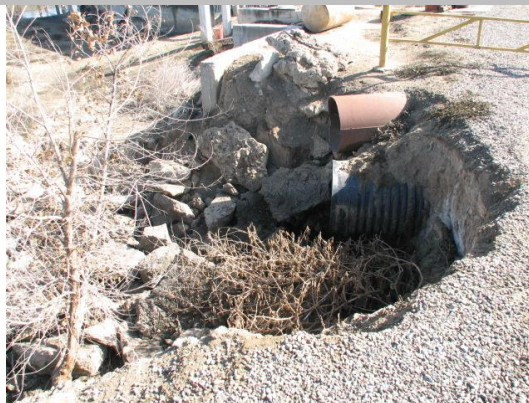
Photo 1 of 2 : mkhashch_s_20140428_00849.jpg

LM Start	2.91	Rating **	M	Issue No.	29
LM End	2.91	Issue Type +	Ma	Location *	WS
Category	Earthen Levee			GPS Latitude/Longitude	
				Start	End
Item	Erosion / Bank Caving			37.639852 °	37.639852 °
				-121.229980 °	-121.229980 °
DWR ID	DWR_RD2101_01_s _ 2012_29				
Action/Comments					
Schedule repair of erosion site prior to the next inspection.

Levee slope is being eroded at this location. Repair needed to preserve access road.

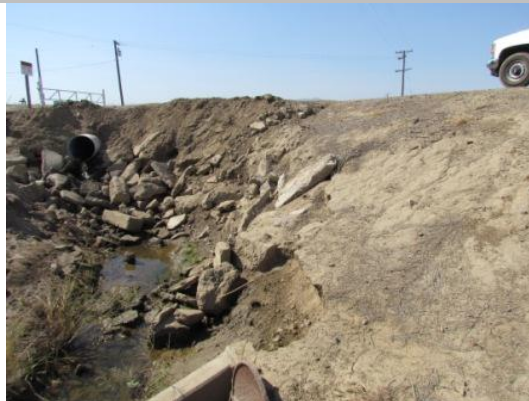
Photo 2 of 2 : mkhashch_s_20140428_00850.jpg

View of repaired site, but it appears that erosion is still occurring. 09/25/2012

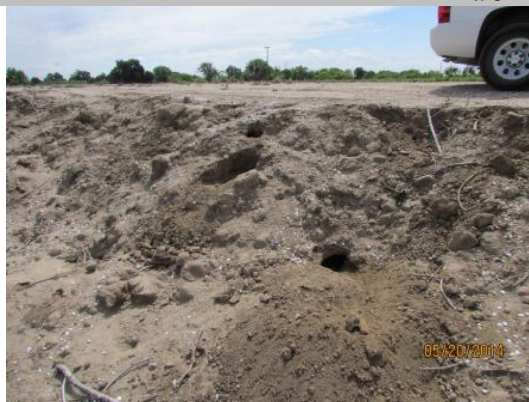
Photo 1 of 1 : mkhashch_s_20140527_01045.jpg

LM Start	3.02	Rating **	M	Issue No.	17
LM End	3.20	Issue Type +	Ma	Location *	LS
Category	Earthen Levee			GPS Latitude/Longitude	
				Start	End
Item	Animal Control			37.638760 °	37.638760 °
				-121.231341 °	-121.231341 °
DWR ID	DWR_RD2101_01_s_2012_17				
Action/Comments					
Exterminate rodents and backfill and compact or grout burrows. Inspector Comments: Active burrows with rodents present.

Numerous burrows present, some already caving in, others are active.

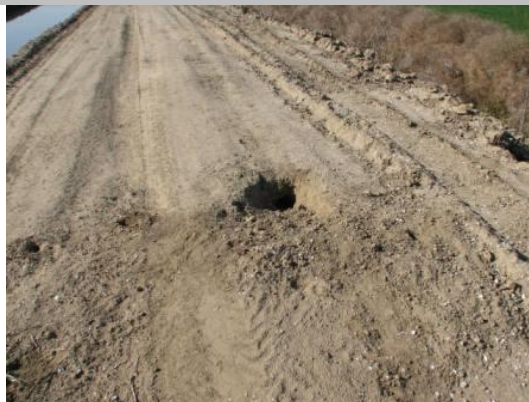
Photo 1 of 3 : mkhashch_s_20140428_00833.jpg

LM Start	3.11	Rating **	M	Issue No.	18
LM End	3.11	Issue Type +	Ma	Location *	CR
Category	Earthen Levee			GPS Latitude/Longitude	
				Start	End
Item	Animal Control			37.637943 °	37.637943 °
				-121.232620 °	-121.232620 °
DWR ID	DWR_RD2101_01_s_2012_18				
Action/Comments					
No rodents visible, but rodent burrows visible; need to backfill and compact or grout burrows.					
Inspector Comments: Large burrow in crown with no rodents present at time of inspection.

11/02/2011 Large burrow in crown.

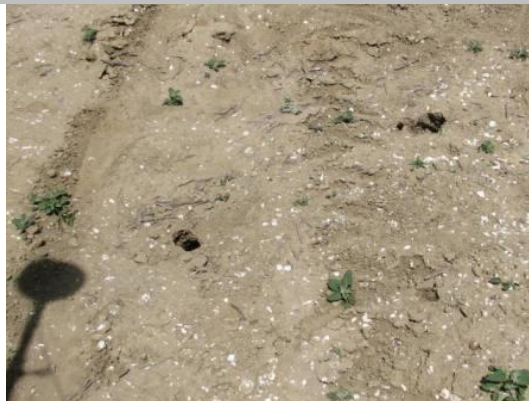
Photo 2 of 3 : mkhashch_s_20140428_00834.jpg

05/02/2012 Rodent holes in the levee crown.

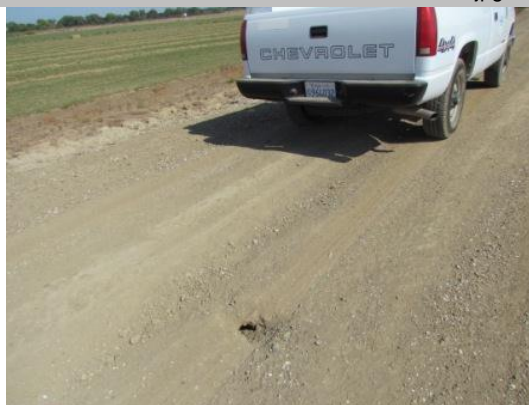
Photo 3 of 3 : mkhashch_s_20140428_00835.jpg

View of the rodent hole in the levee crown. Smaller holes were covered due to crown regrading. 09/25/2012

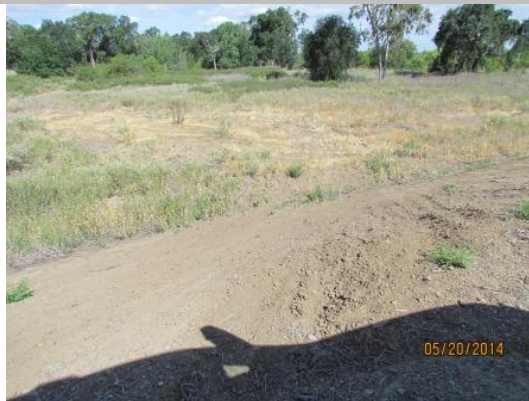
Photo 1 of 1 : mkhashch_s_20140527_01046.jpg

LM Start	0.02	Rating **	M	Issue No.	4
LM End	0.02	Issue Type +	Ma	Location *	WS
Category	Earthen Levee			GPS Latitude/Longitude	
				Start	End
Item	Slope Stability			37.660055 °	37.660055 °
				-121.243446 °	-121.243446 °
DWR ID	DWR_RD2101_02_s_2014_4				
Action/Comments					
Repair the levee slope damaged by vehicle traffic and prevent access where possible.

View of the vehicle tracks on the waterside levee slope causing levee damage.

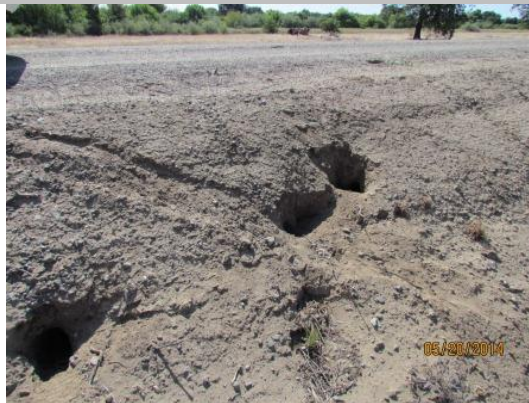
Photo 1 of 1 : mkhashch_s_20140527_01047.jpg

LM Start	0.23	Rating **	M	Issue No.	2
LM End	0.23	Issue Type +	Ma	Location *	WS
Category	Earthen Levee			GPS Latitude/Longitude	
				Start	End
Item	Animal Control			37.662968 °	37.662968 °
				-121.242674 °	-121.242674 °
DWR ID	DWR_RD2101_02_f_2013_2				
Action/Comments					
No rodents visible, but rodent burrows visible; need to backfill and compact or grout burrows. Inspector Comments: LMA possibly corrected this issue.

View of the rodent burrows on waterside levee slope.
